# ***CAL FIRE***

## **INVESTIGATION REPORT**

<b>INCIDENT NUMBER:</b>	17-CA-NEU-026269
<b>CASE NUMBER:</b>	17-2320-122
<b>CASE NAME:</b>	CASCADE
<b>DATE:</b>	October 8, 2017
<b>INCIDENT TYPE:</b>	Wildland Fire
<b>INCIDENT INVESTIGATORS:</b>	Mike RUFENACHT, Battalion Chief – NEU Chris VAN COR, Division Chief –SAC Karen VILLALOBOS, Battalion Chief - SAC Jeremy MONROE, Deputy Chief– SAC

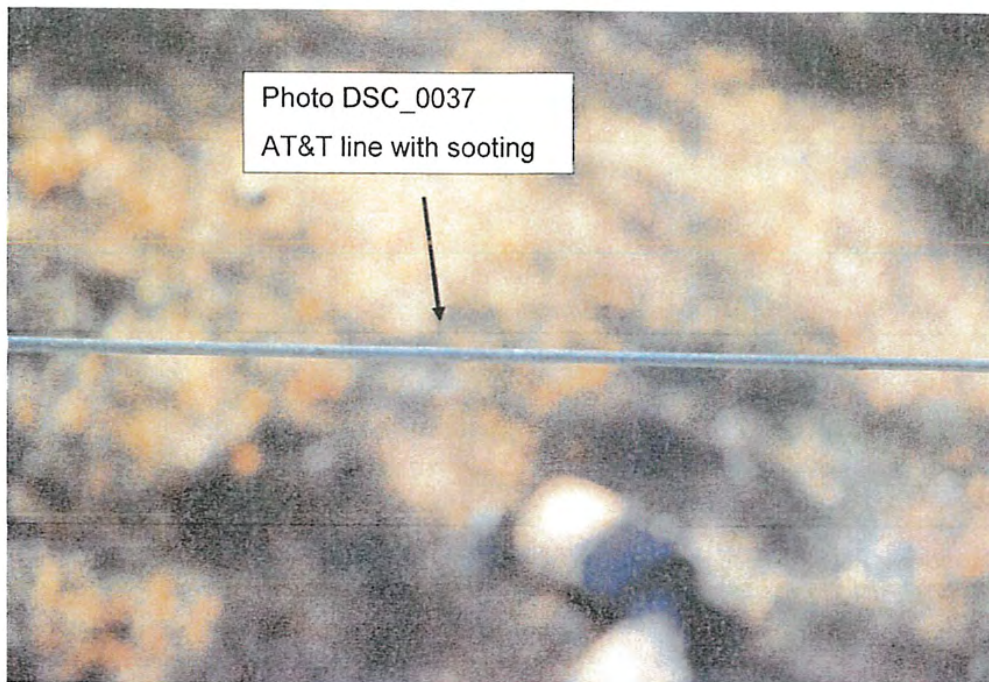
2 Examining the PG&amp;E conductors the from the bucket truck, I observed sag in the lines.

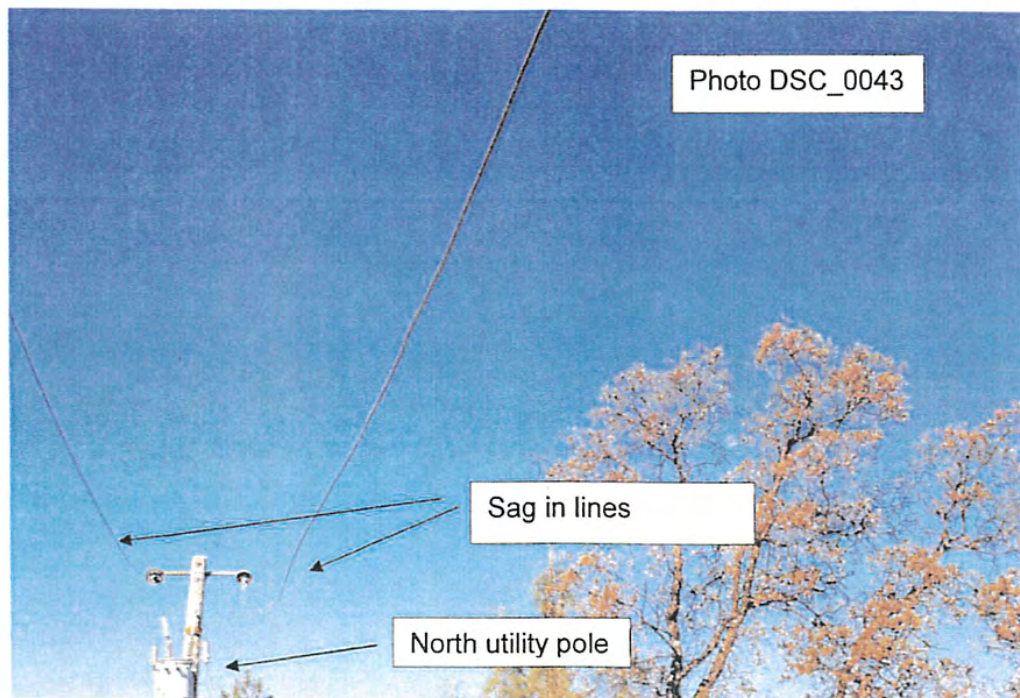
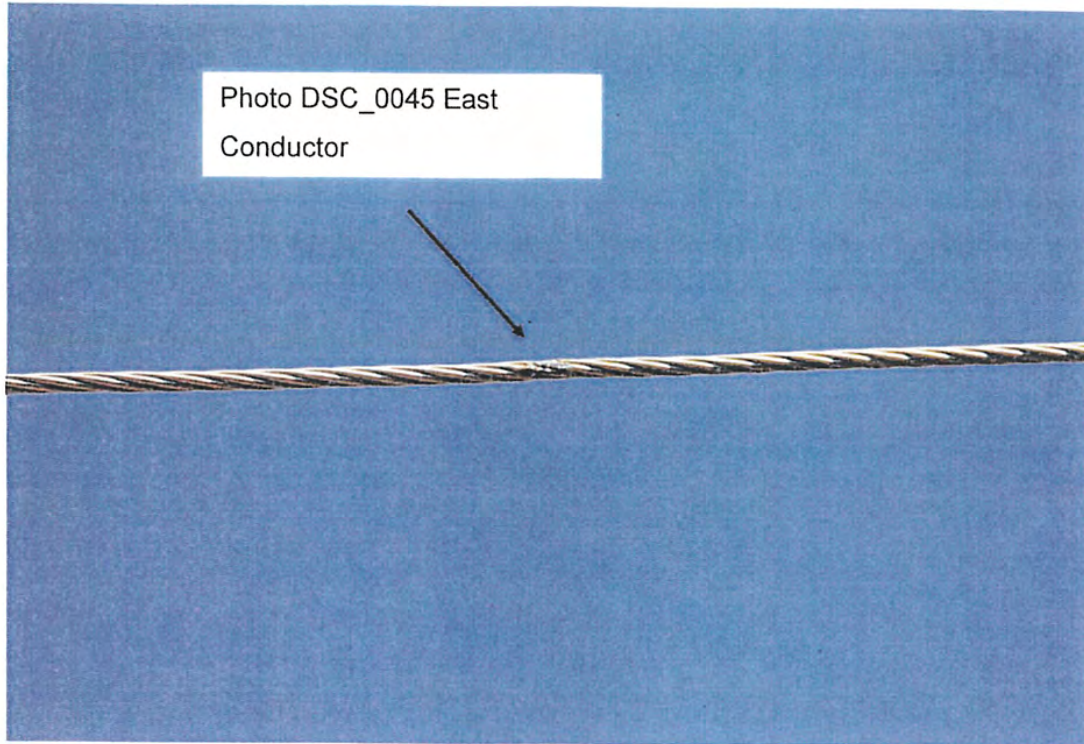
- 1 From the bucket truck, I observed and photographed an irregularity on both the east  
2 and west conductors. The irregularities appeared to be damage to the lines. The  
3 damage appeared to be close to the same distance between the north and south utility  
4 poles. Jim NOLT completed an independent report of the electrical equipment at the  
5 scene (Attachment -7).

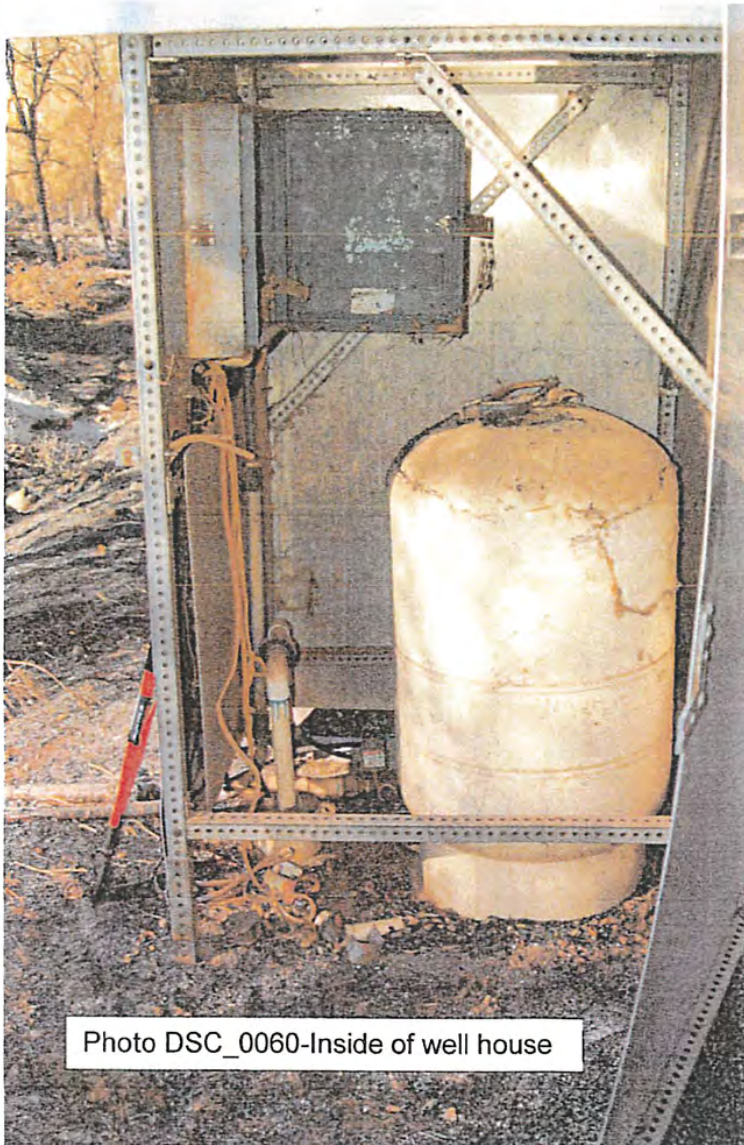
1  
2 NOLT and I examined the well house to the RIDDLE property. Fire pattern indicators  
3 showed the fire moving toward the well house from the area of the north and south  
4 utility poles on the RIDDLE property. NOLT examined the well house electrical to rule  
5 the well house out as the cause of the fire (See Attachment 7 – NOLT Report). The well  
6 house was locked, and we cut the lock to gain access to the small metal enclosure.  
7 The inside of the well house was not consumed by fire (See photo DSC\_0060).

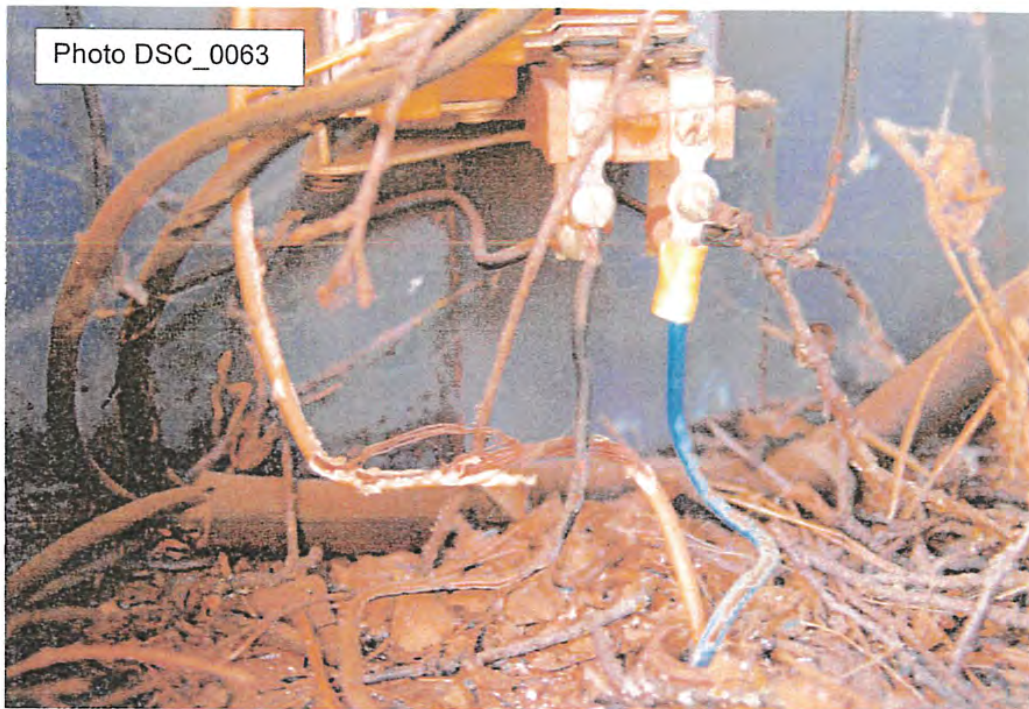
- 1  
2 The electrical panel inside of the well house appeared to be weathered and damaged  
3 by rodents (see photo DSC\_0063).  
4  
5  
6  
7

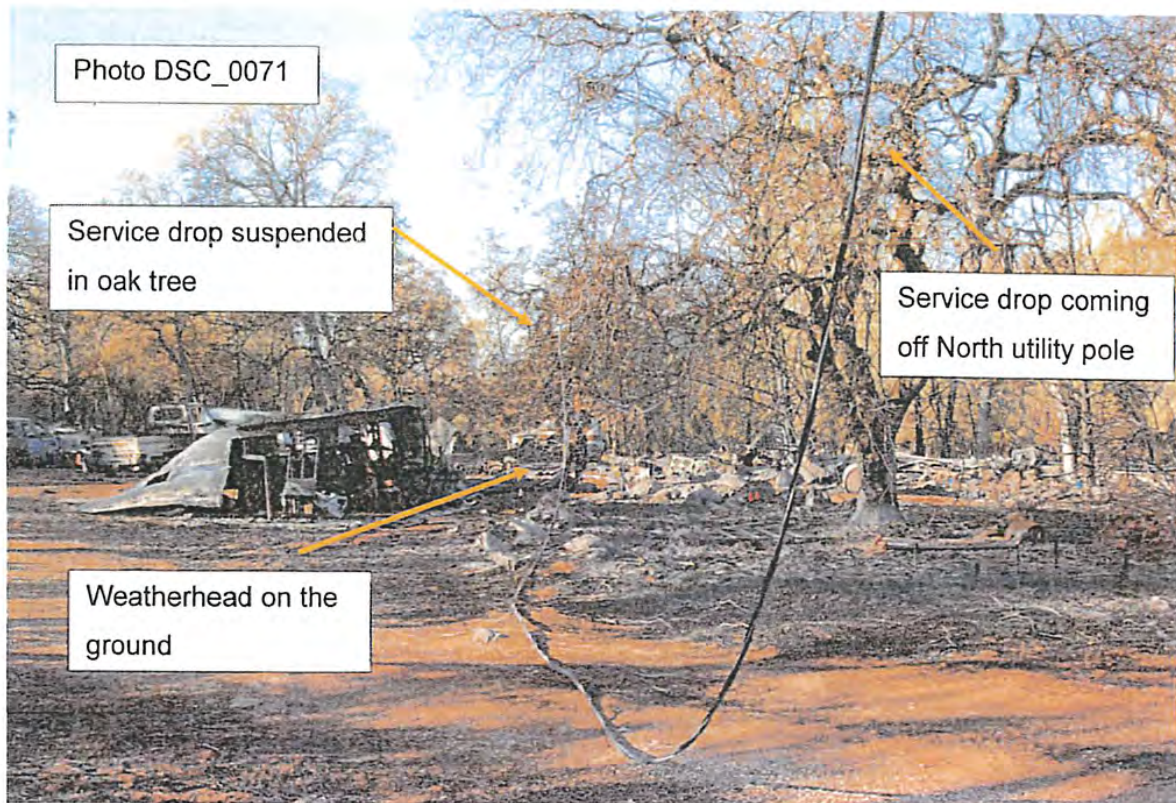
1  
2 NOLT examined the electrical (See NOLT report attachment 7) and the well shed was  
3 closed and sealed with plastic ties at the lock hasp.  
4 NOLT and I checked the drop line coming off the north utility pole going to the  
5 weatherhead near the 5<sup>th</sup> wheel trailer. The service drop came off the pole and was  
6 lying on the ground (See photo DSC\_0071). From the ground, the service drop went up  
7 off the ground held by an oak tree and was found near the weatherhead by the 5<sup>th</sup>  
8 wheel trailer.

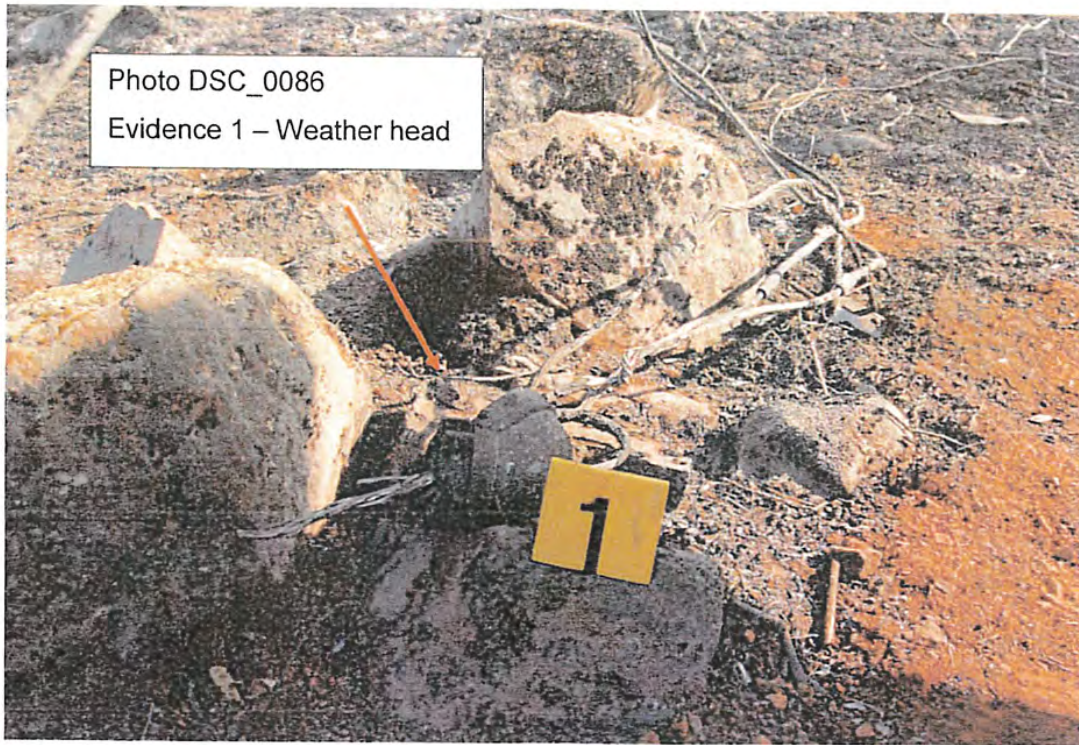
I was unable to locate any tree branches on the drop line which would suggest the tree caused the drop line to contact the ground. I was unable to locate any limb damage, charring, pitting, or staining on the tree which would have been indicative of a live conductor making contact with the tree. The weatherhead, electrical meter, and electrical panel to the 5<sup>th</sup> wheel trailer were collected as evidence and sent to Anamet Inc. for further laboratory testing due to the extent of fire damage to the equipment. NOLT also looked at this equipment for analysis (See NOLT report - Attachment 7).
