# ***CAL FIRE***

## **INVESTIGATION REPORT**

<b>INCIDENT NUMBER:</b>	17-CA-NEU-026269
<b>CASE NUMBER:</b>	17-2320-122
<b>CASE NAME:</b>	CASCADE
<b>DATE:</b>	October 8, 2017
<b>INCIDENT TYPE:</b>	Wildland Fire
<b>INCIDENT INVESTIGATORS:</b>	Mike RUFENACHT, Battalion Chief – NEU Chris VAN COR, Division Chief –SAC Karen VILLALOBOS, Battalion Chief - SAC Jeremy MONROE, Deputy Chief– SAC

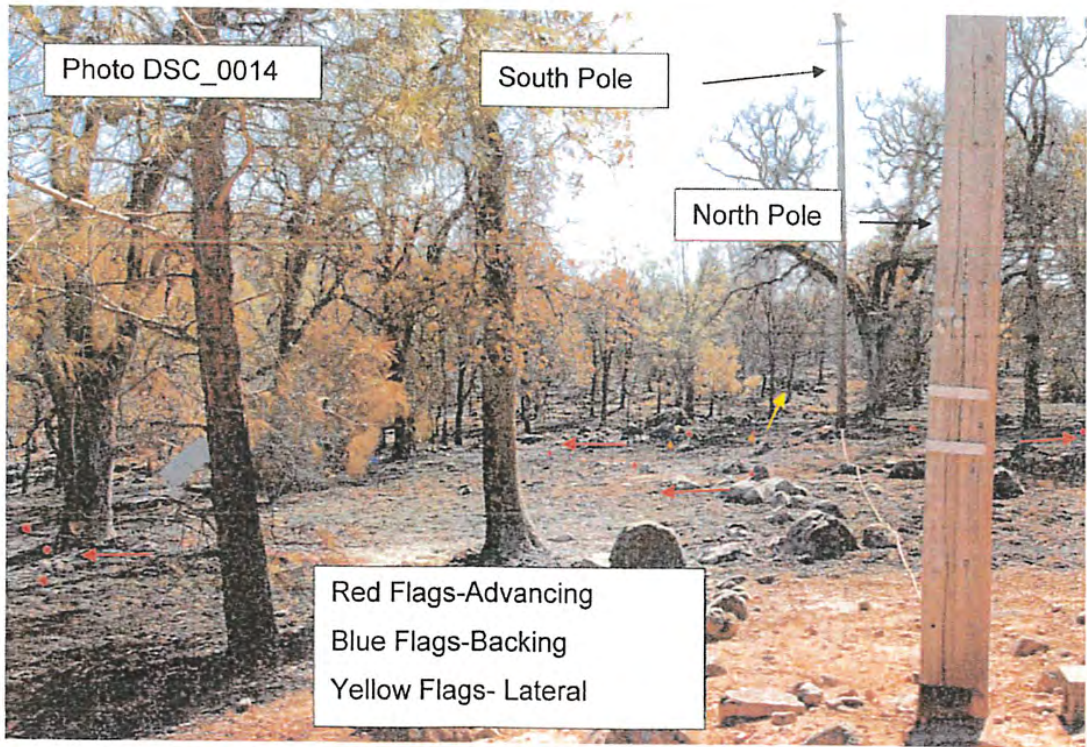
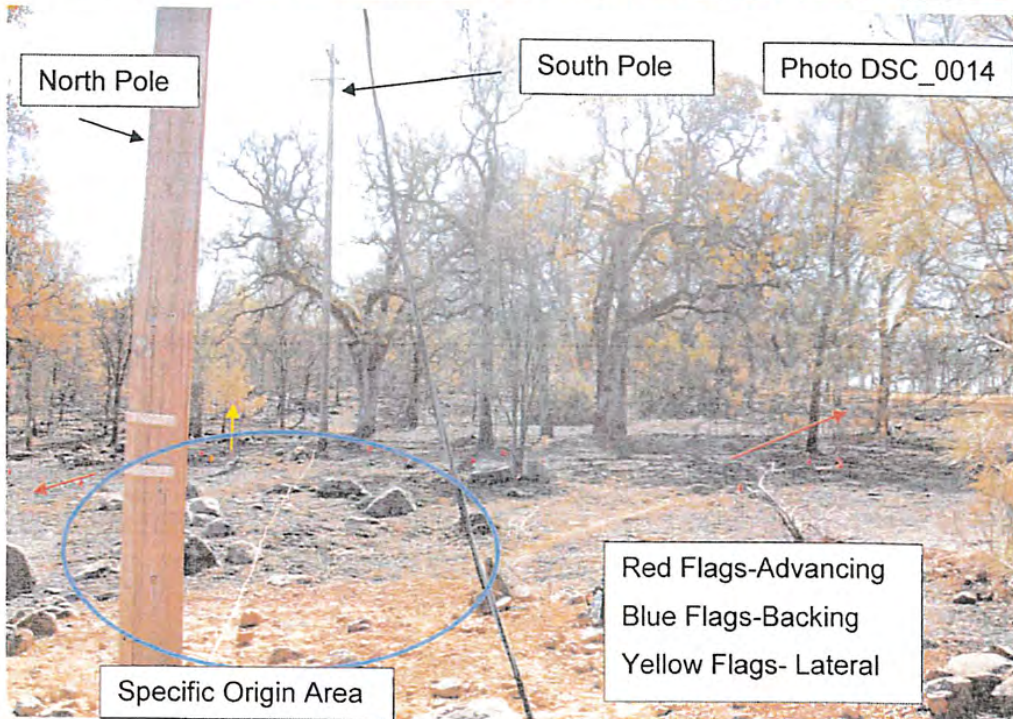
9 On Friday October 13, 2017 at 10:15 AM I arrived with Jim NOLT (J H Nolt  
10 Associates Electrical, Mechanical, and Corrosions Engineers) and BARCKLAY at 13916  
11 Cascade Way. I continued adding fire pattern indicator flags, and verified the fire pattern  
12 indicator flags VILLALOBOS and MONROE had placed indicating the GOA. The fire  
13 pattern indicator flags underneath the north and south utility poles on the RIDDLE  
14 property showed advancing fire indicators going away from the area below the  
15 conductors in the dead and dry annual grasses. This area was identified as the Specific  
16 Origin Area (SOA).

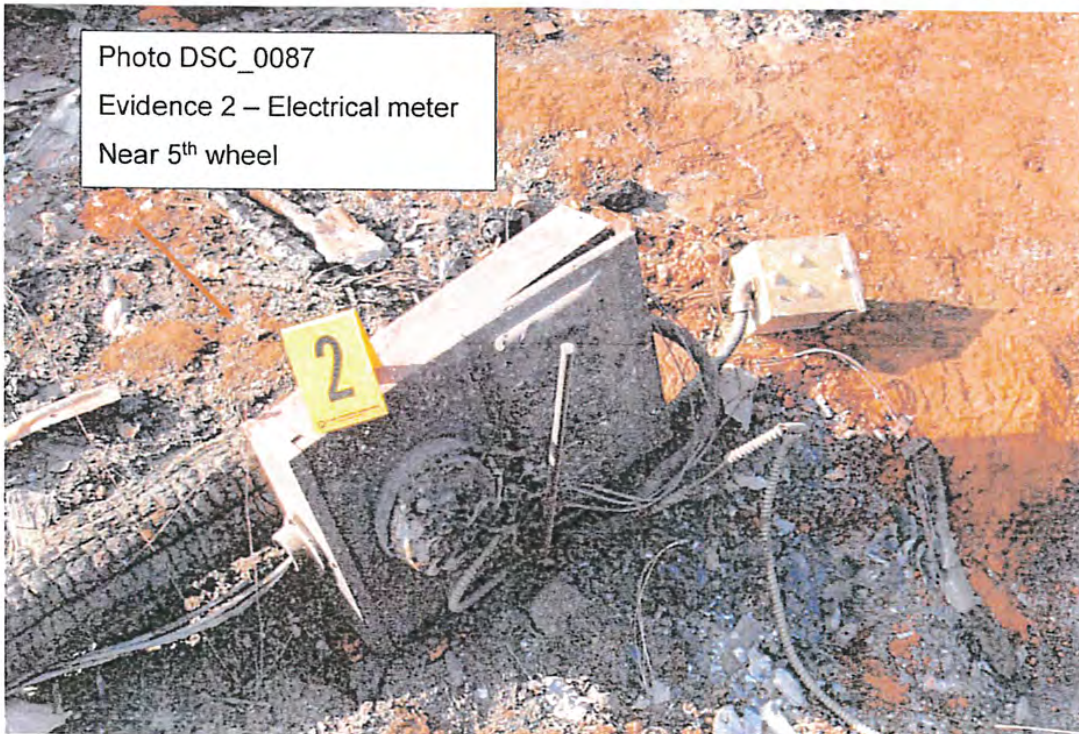
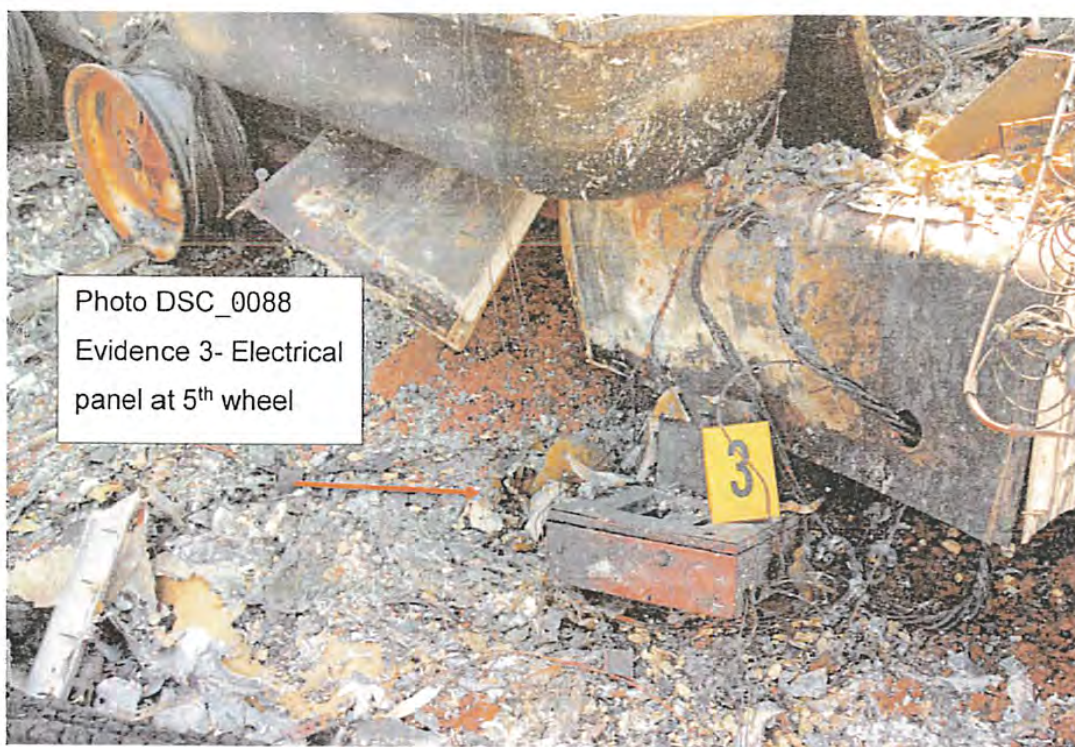
1  
2 NOLT examined the electrical (See NOLT report attachment 7) and the well shed was  
3 closed and sealed with plastic ties at the lock hasp.  
4 NOLT and I checked the drop line coming off the north utility pole going to the  
5 weatherhead near the 5<sup>th</sup> wheel trailer. The service drop came off the pole and was  
6 lying on the ground (See photo DSC\_0071). From the ground, the service drop went up  
7 off the ground held by an oak tree and was found near the weatherhead by the 5<sup>th</sup>  
8 wheel trailer.

1  
2 Following the wiring from the service drop to the electrical meter, I found wiring going to  
3 the 5<sup>th</sup> wheel and well house on the RIDDLE property. I was unable to locate any wiring  
4 going to the travel trailer or shop on the RIDDLE property.

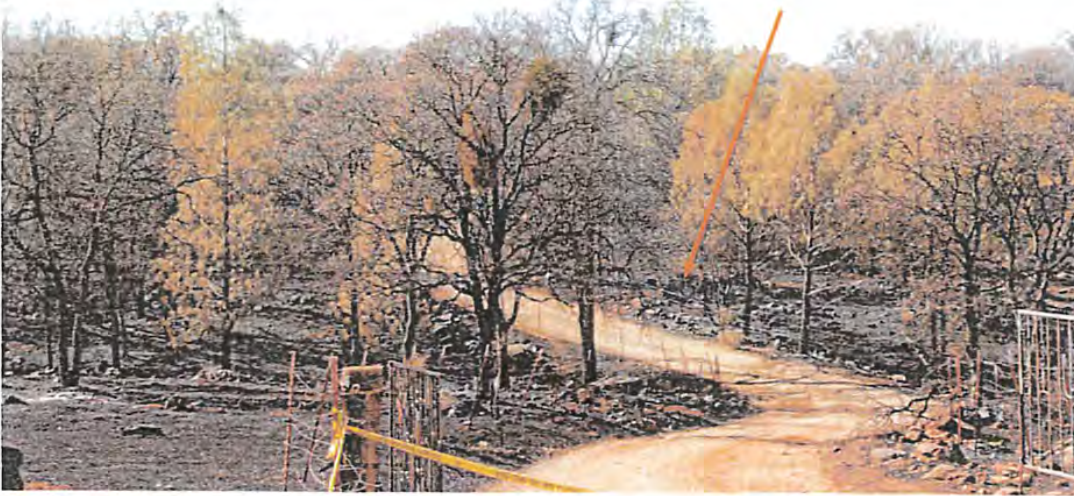
Photo DSC\_0085-Taken by DANILYAN

Driveway at [REDACTED] (JOHNSON property)
